Component Replacement

- electrical –

Xperia™ XZ
F8331, F8332 (Dual SIM)

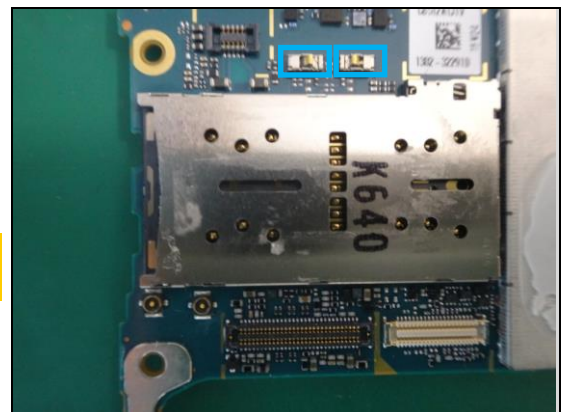
Primary Side 3

CN8650, CN8651

Replace if mechanical damaged (No or bad network, antenna).
